## Water Compliance Inspection Report

***NPDES  
Inspection Report***

***United States Department of the Interior  
Bureau of Reclamation  
Elwha Water Treatment Plant***

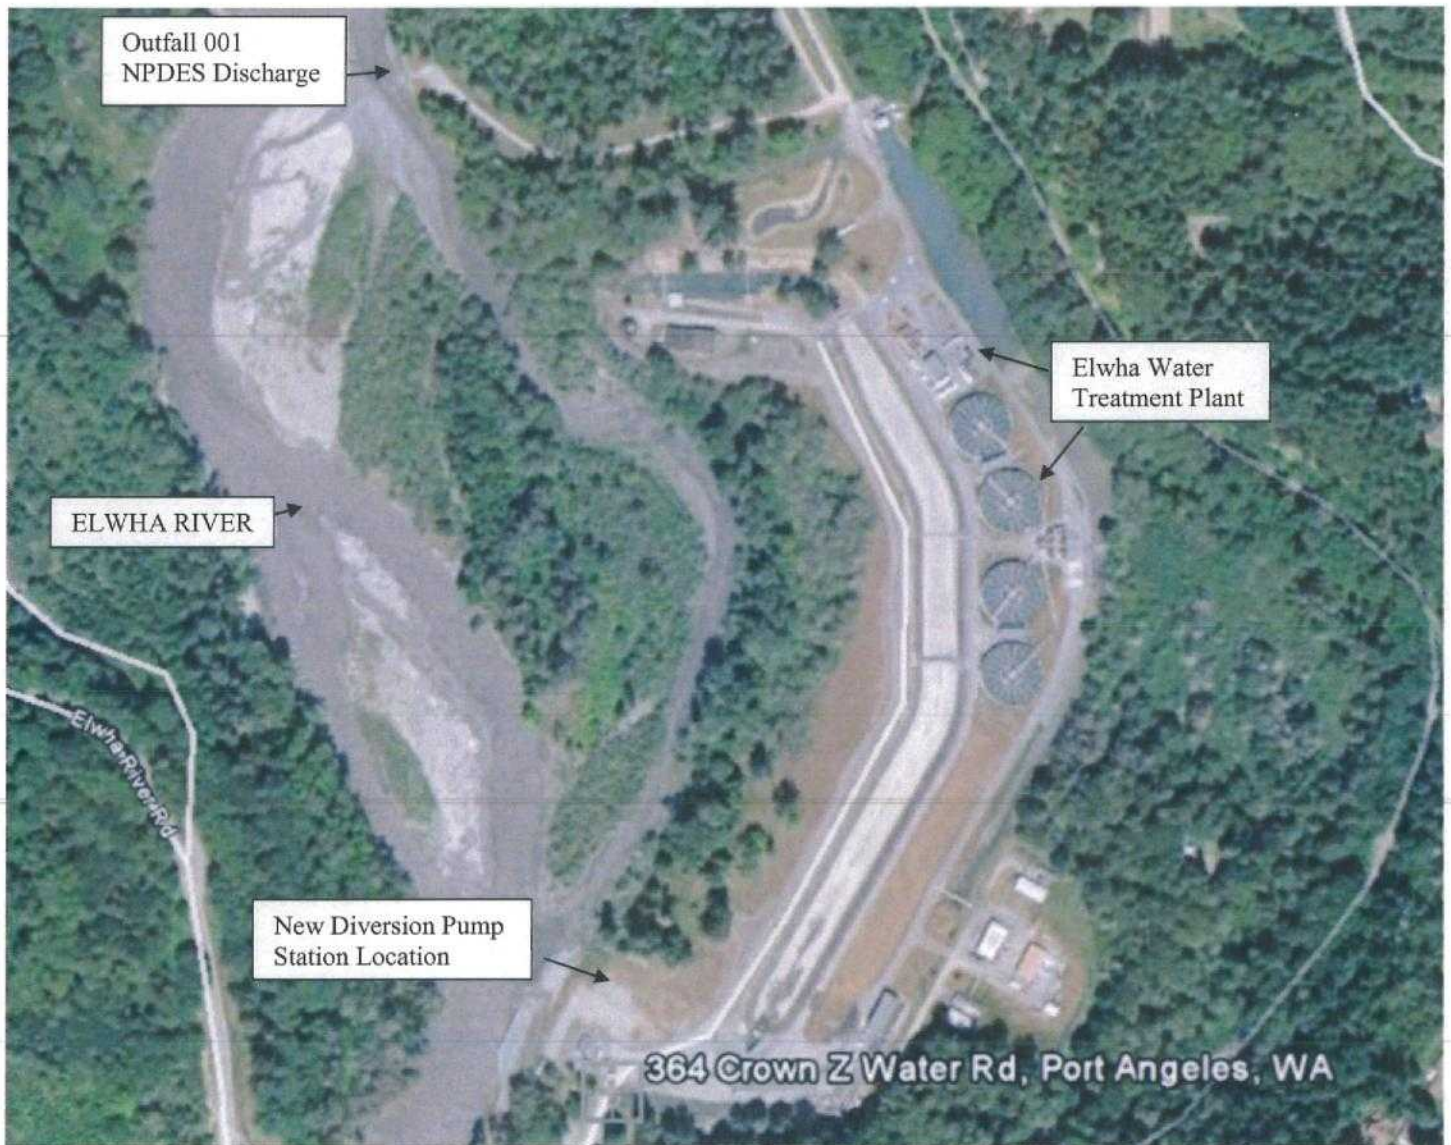
## Site Map #1

The plant is designed to draw water from the Elwha River with a high solids content, remove the solids to acceptable levels, distribute the treated water to municipal and industrial facilities and discharge the removed solids to the river downstream of the user intakes. See Attachment A, Site Map #1 & Site Map #2.

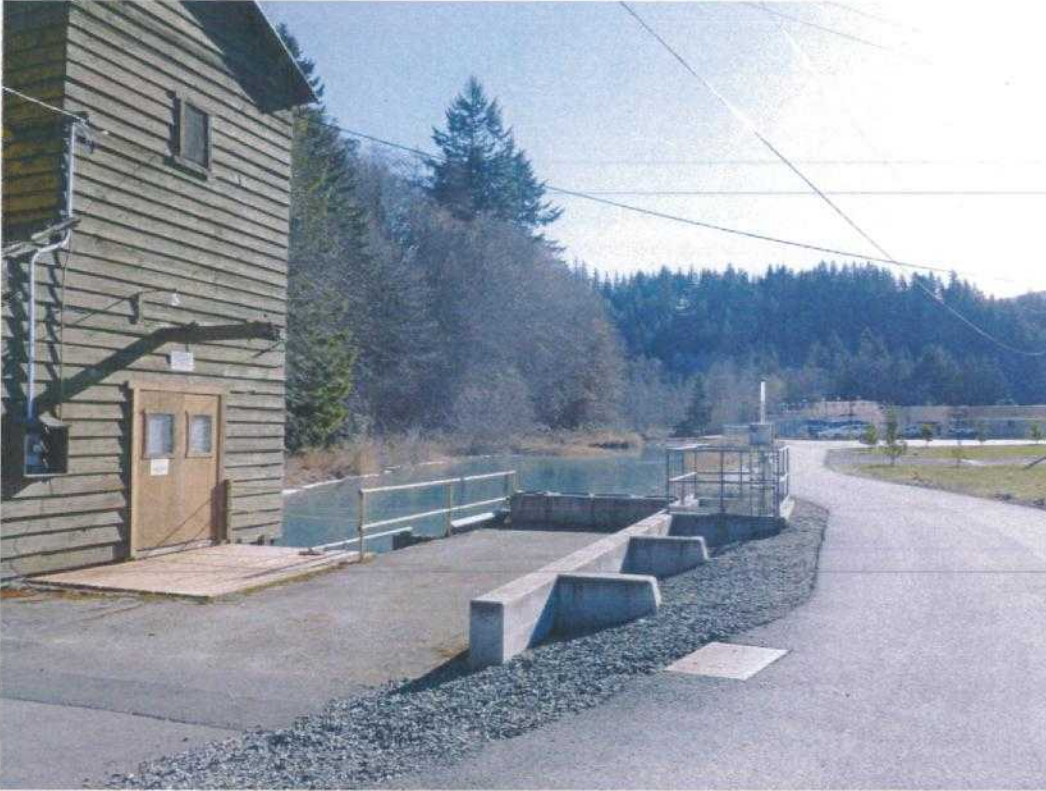
Nippon Paper Industries USA receives the largest quantity from the plant at 10 million gallons per day (Mgal/d). The Port Angeles Water Treatment Plant receives the second largest quantity at 2.3 Mgal/d. The treated water, about 14.2 Mgal/day in total, is distributed to the users via gravity, with the exception of the Port Angeles Treatment Plant which is pumped. See Attachment B, Photo #1 to view the industrial water channel.

**Photo #1:** Southeasterly view of the industrial channel. The intake to the NPI paper mill is located south of the building that appears on the left. The treatment plant appears in the background.

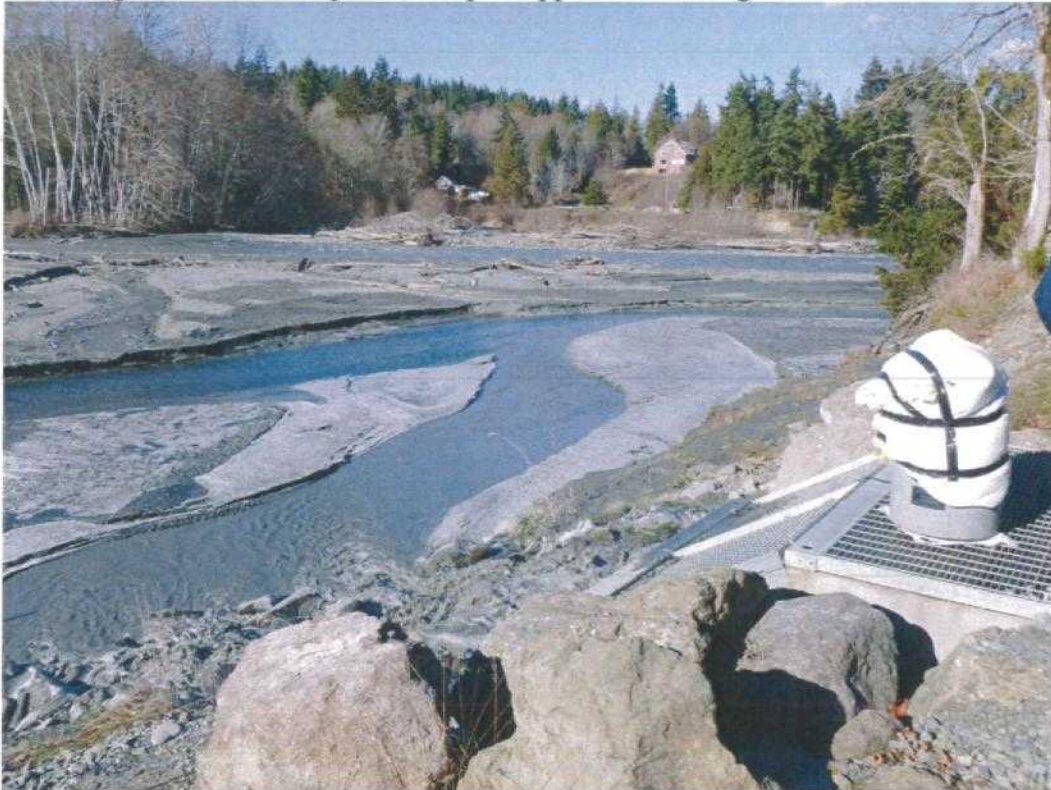
The permit authorizes the return of the removed sediment to the river, downstream of the treatment plant and user intakes. See Attachment B, Photo #2 to view the discharge from outfall 001.

**Photo #2:** Northwesterly view of the discharge from Outfall 001. The Elwha River appears in the background. The composite sampler appears on the right.

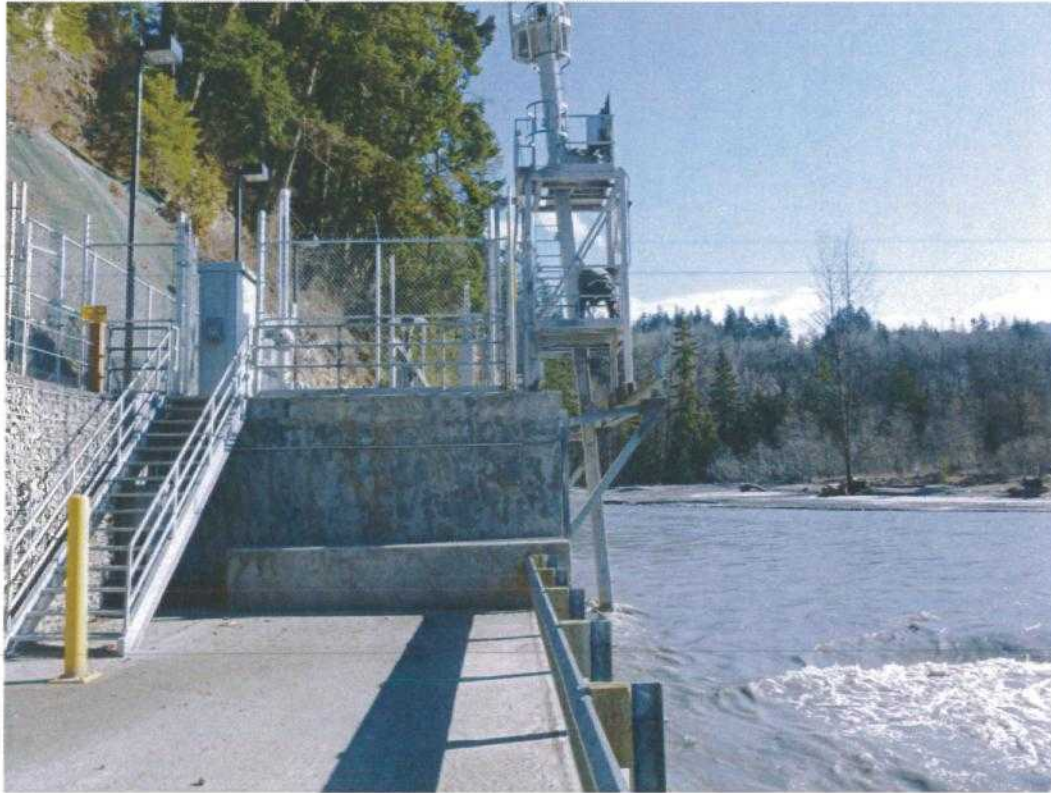
Water is drawn from the Elwha River from an intake structure and pumped through a fish screening process prior to treatment. The EWTP is a sedimentation plant and uses physical and chemical coagulation, flocculation and sedimentation processes to remove solids from the influent water. The plant utilizes 4 large clarifiers in the treatment process, and chemicals are added to adjust pH and to coagulate the solids in the water to accelerate and improve the settling process. The chemicals include Sulfuric Acid, Sodium Hydroxide and Polyaluminum Chloride (PAC) and occasionally small quantities of Polyacrylamide. See Attachment B, Photos #3-#6.

**Photo #3:** Southeasterly view of the intake structure.

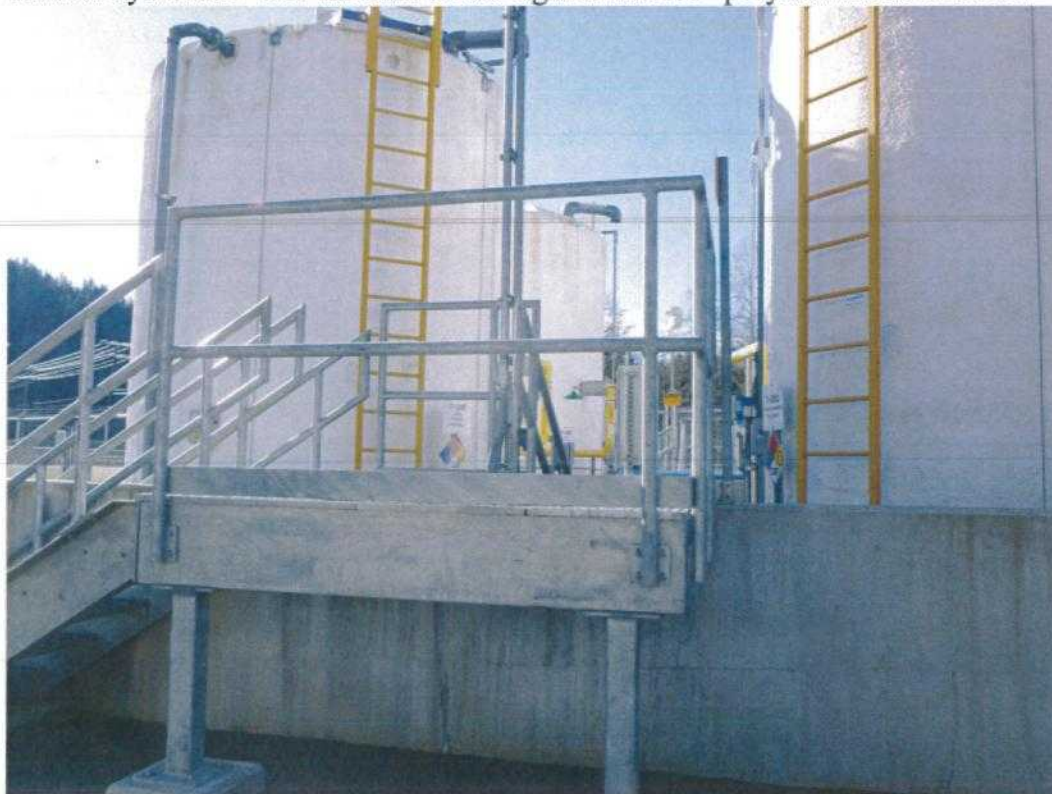
**Photo #4:** Westerly view of the chemical storage area. The tank on the left is labeled “25% sodium hydroxide” and the tank on the right is labeled “polyaluminum chloride.”

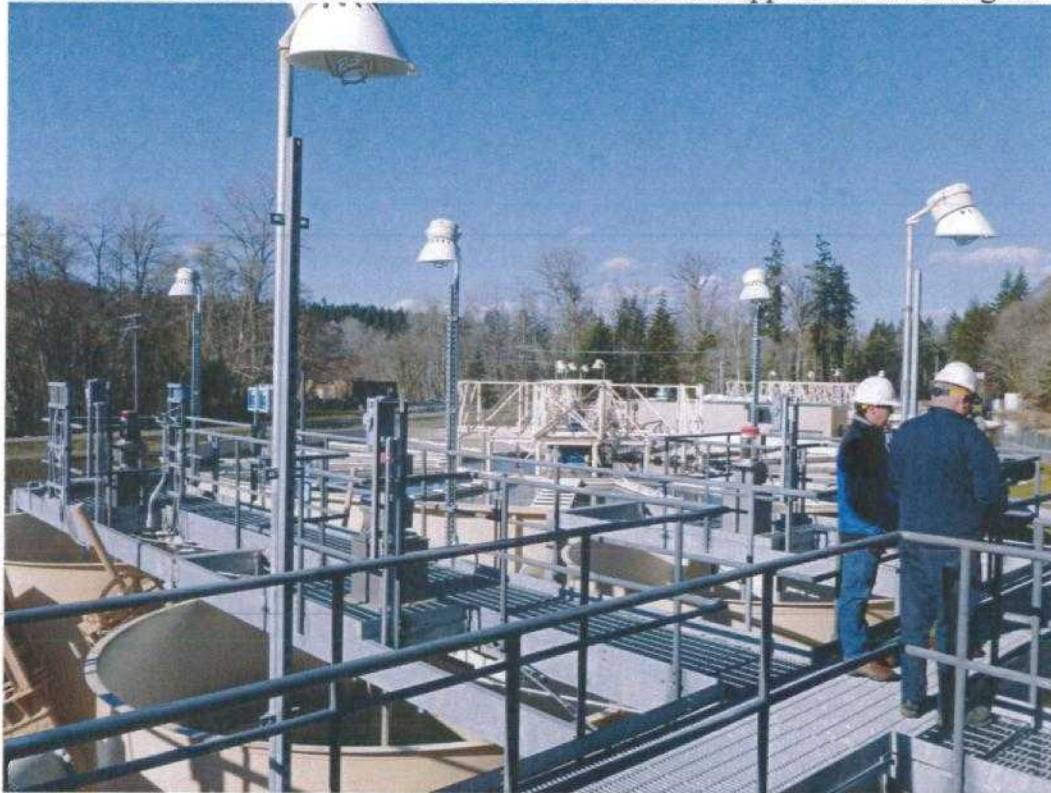
**Photo #5:** Northwesterly view of the chemical mixing tanks. After mixing, flow is distributed between four sedimentation tanks. A sedimentation tank appears in the background.

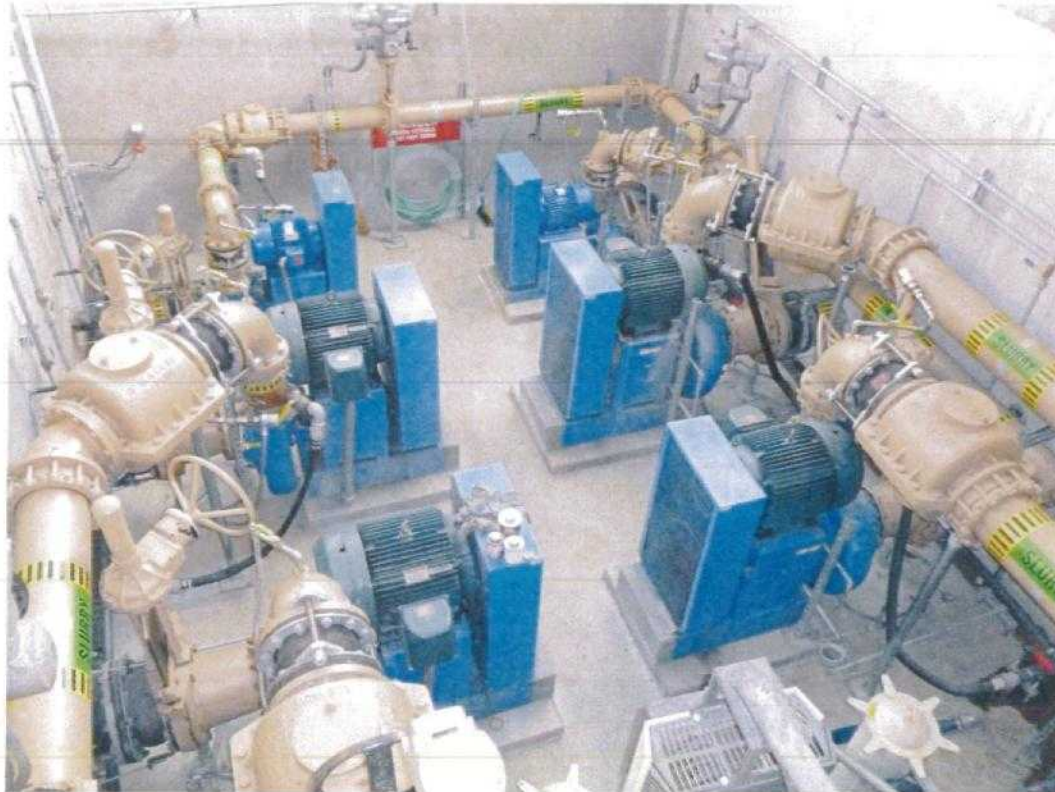
**Photo #6:** View inside the slurry pump station. These pumps deliver slurry from the sedimentation tanks to Outfall 001.

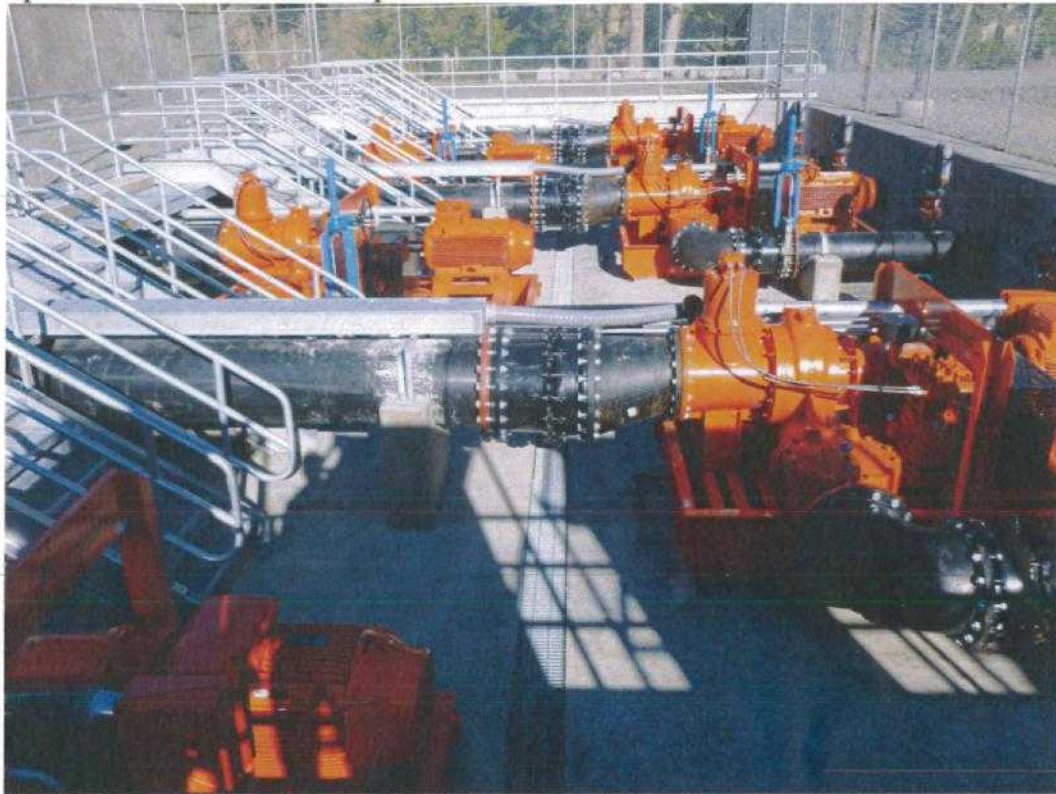
At the time of inspection during the facility tour, we visited the new diversion pump station that had just been constructed along the southwest corner of the facility. The pump station was redesigned and built under contract by HDR, Inc. to solve intake problems that the facility has experienced due to the large quantity of sediment being drawn from the river.

The structure for the pump station has a new stormwater discharge from the

structure's basin which is designed to discharge to the Elwha River from an oil/water separator. The basin was not discharging at the time of inspection. See Attachment B, Photo #7 and Photo #8. Mr. Hubbard stated that Veolia Water is currently not under contract to operate the new pump station.

**Photo #7:** Northerly view of the new diversion pump station. These pumps were recently installed next to the backup diversion pumps. The new diversion pump station was not yet operational at the time of inspection.

I recommended to Mr. Hubbard that the pump station discharge be added to the recent permit renewal package so that EPA is aware of the new structure and the associated stormwater discharge. I also informed Mr. Hubbard that EPA may contact the facility to discuss the discharge in greater detail.

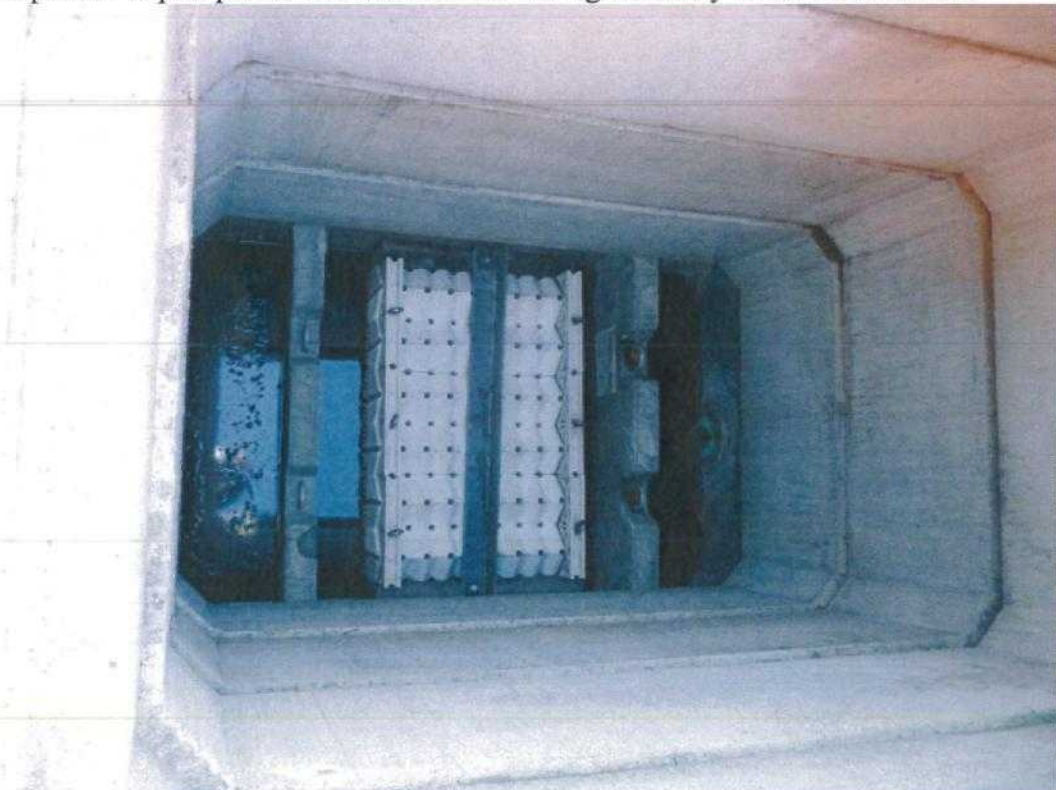
**Photo #8:** View inside the oil/water separator that receives stormwater from the floor drain of the new diversion pump station that appears in the previous photograph. Effluent from the separator is pumped to the Elwha River through a newly constructed outfall.
